Advisory Region Northern Gallatin Longitude -110.97W Latitude 45.39N Avalanche Details: Widespread Avalanching in Divide Drainage Northern Gallatin, 2019-01-26

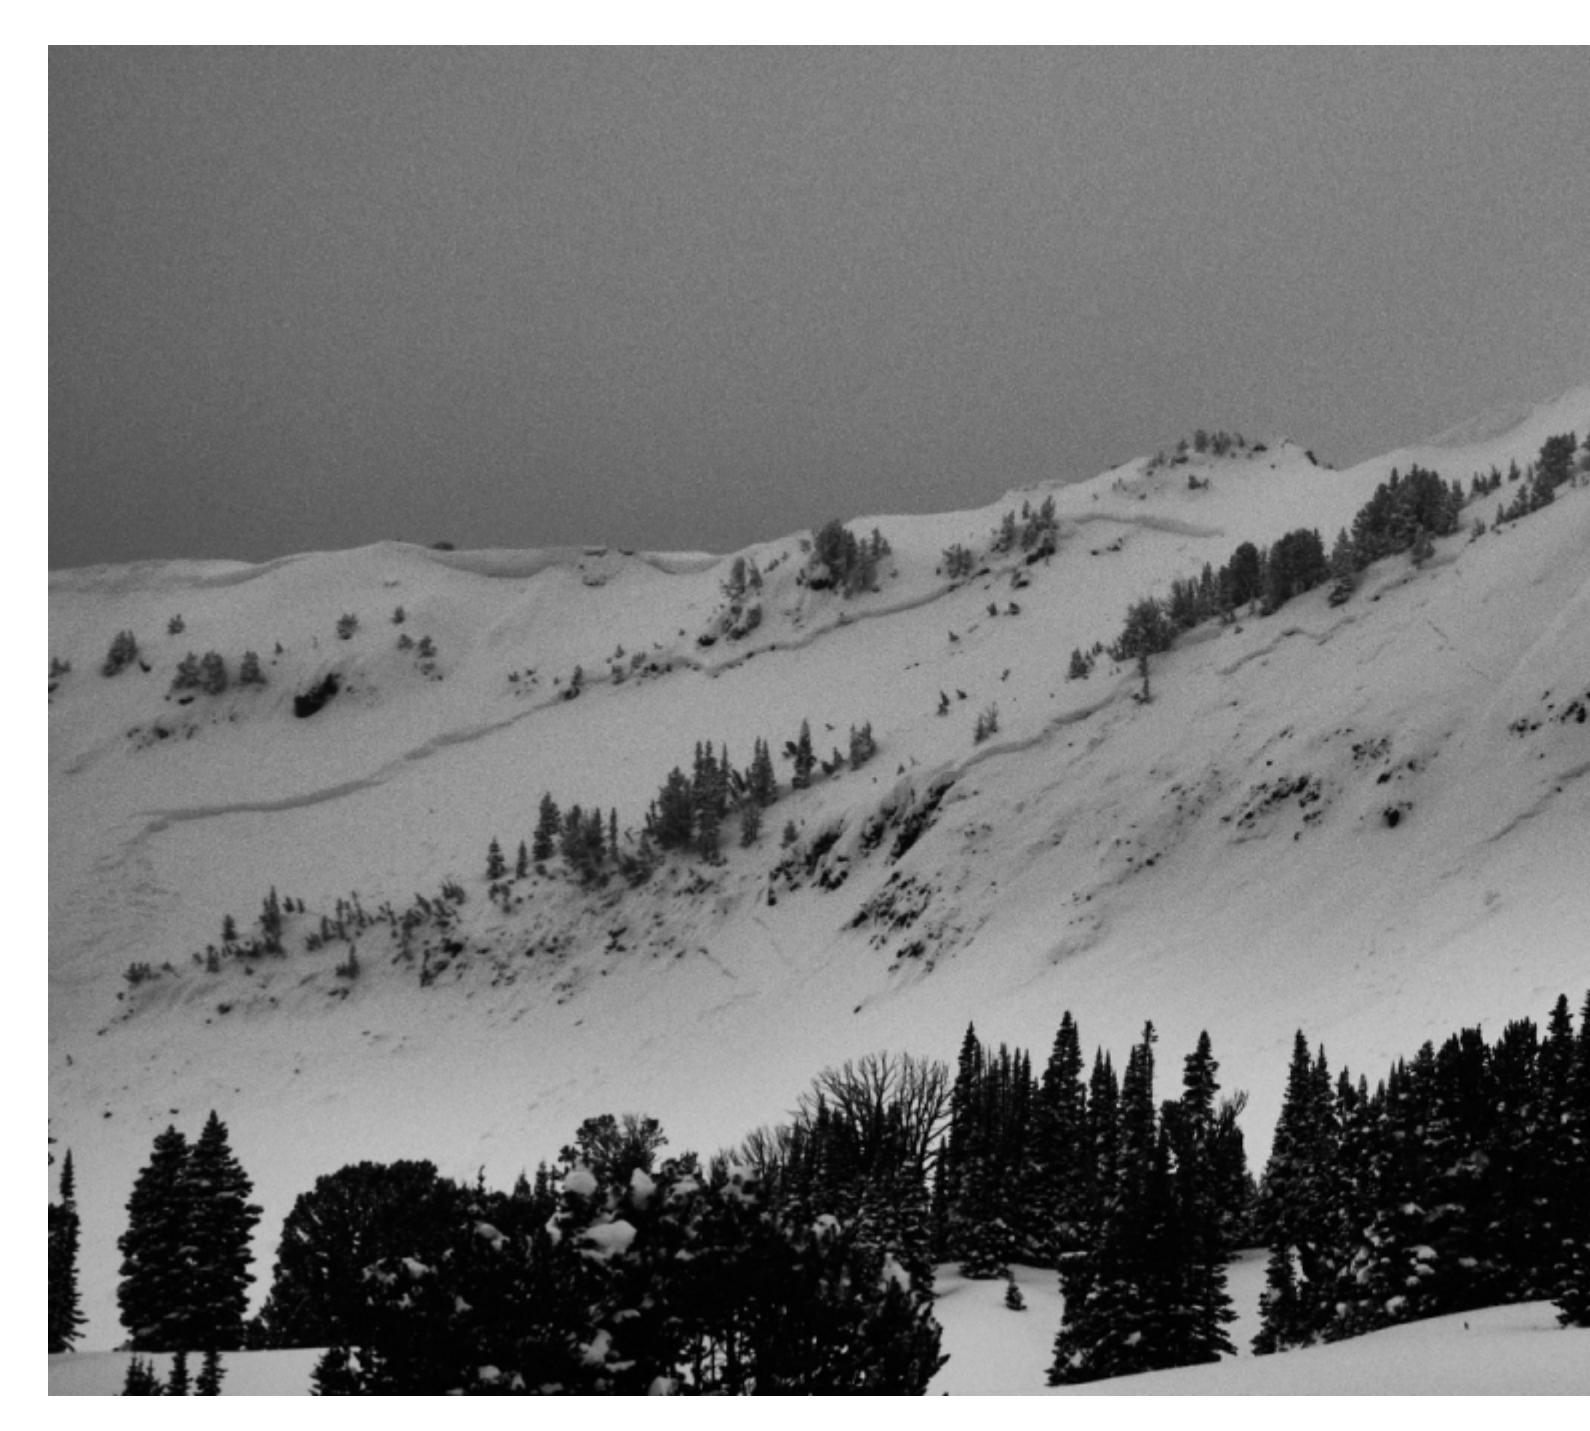
A skier in Hyalite reported widespread avalanche activity in the Divide drainage. From the email: "Saw this set of crowns just to the looker's left of Divide Peak proper. Appear to be cornice triggered, I suspect they all released sympathetically, maybe sometime yesterday. Impressively connected, definite PWL issue. SE aspect. Crowns spanned nearly 1/2 mile of terrain." Photo: B. VandenBos
