Advisory Region Bridger Range Longitude -110.93W Latitude 45.83N Bridger Range, 2021-12-08

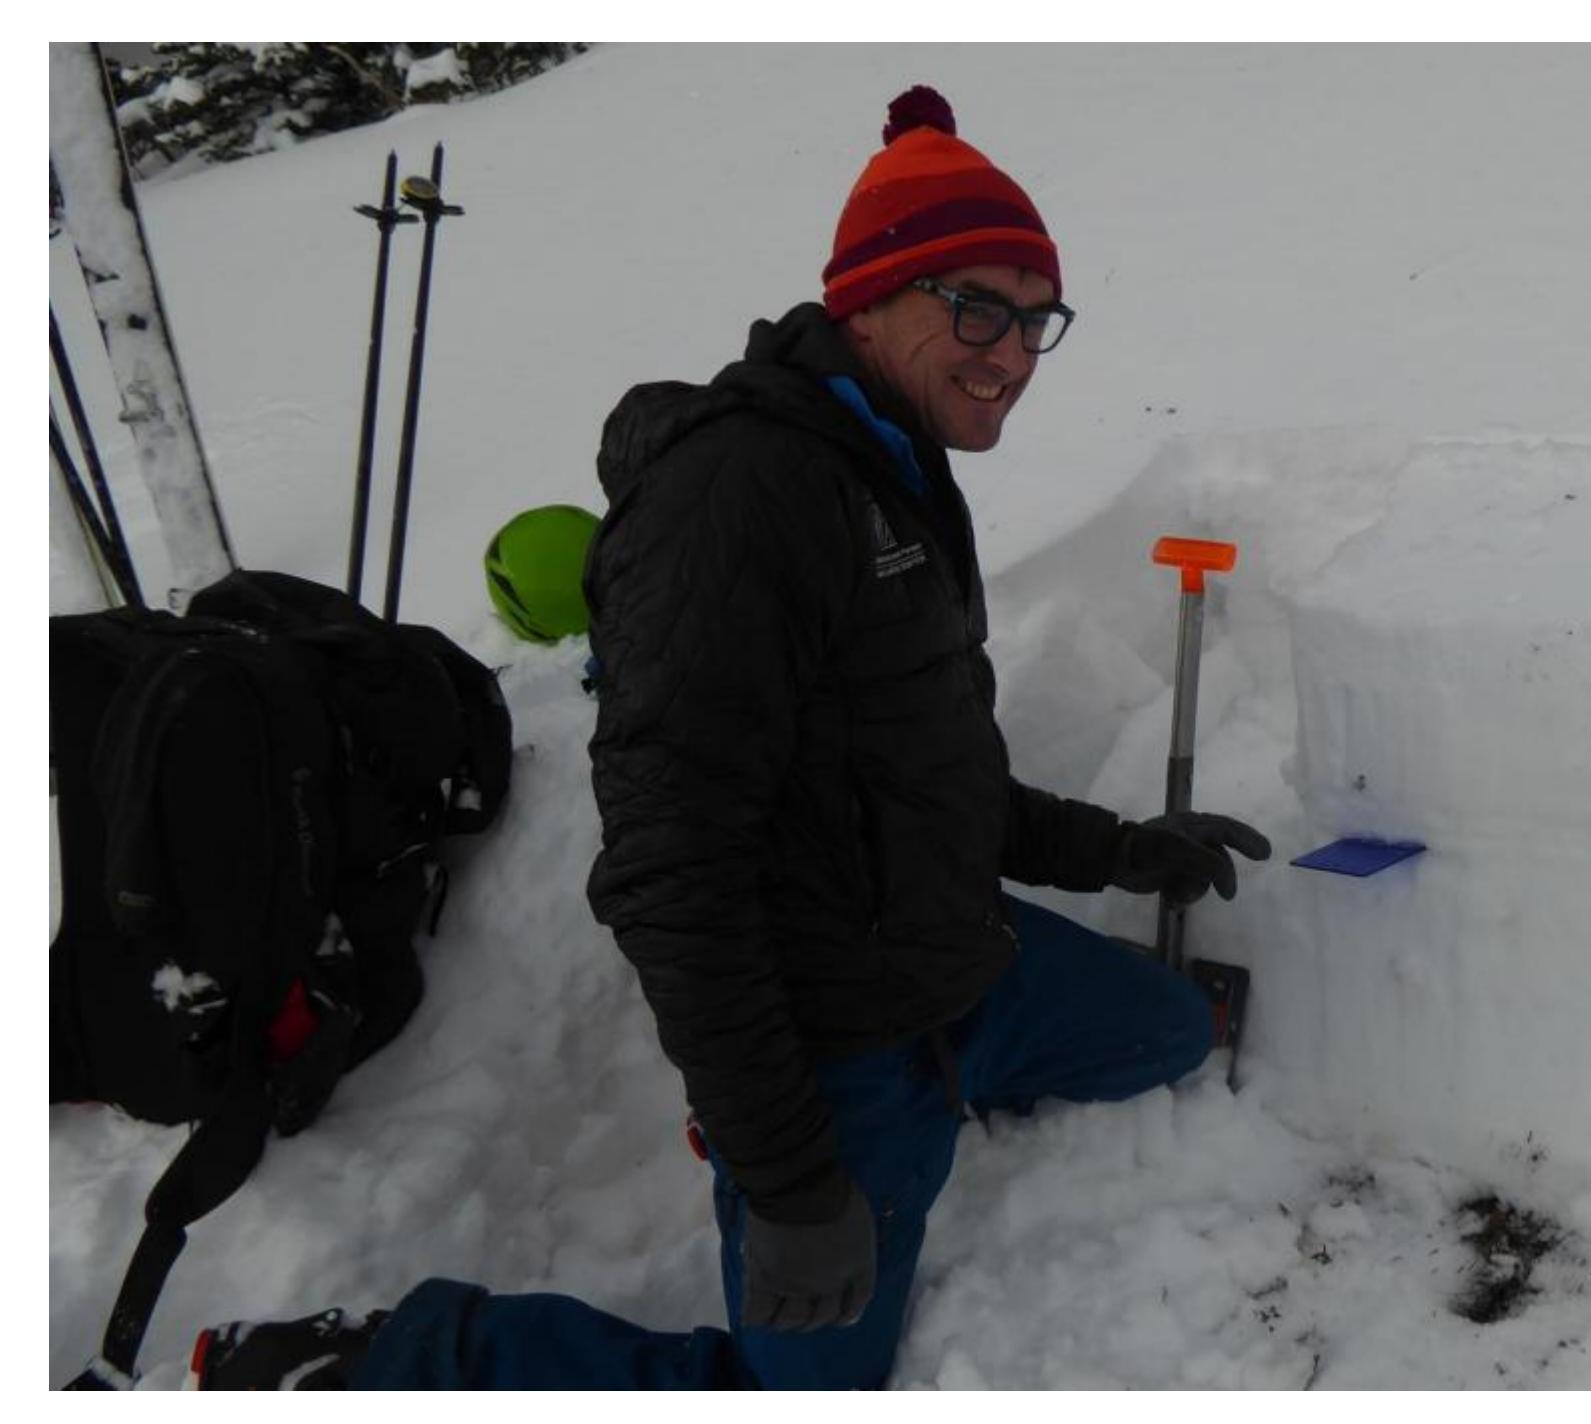
We found 80 cm (2+ feet) of snow on a NE facing slope at 8,000 feet outside Bridger Bowl's Boundaries. The snow was supportable with a weak layer at the blue card. Faceted, weak, sugary snow is the layer of concern, but it was not that bad...yet. We'll be watching to see if it gets weaker. Photo: GNFAC
