Advisory Region Northern Madison Longitude -111.38W Latitude 45.17N **Avalanche Details:** <u>Cornice Triggered Avalanche Buck Ridge</u> Northern Madison, 2022-12-10

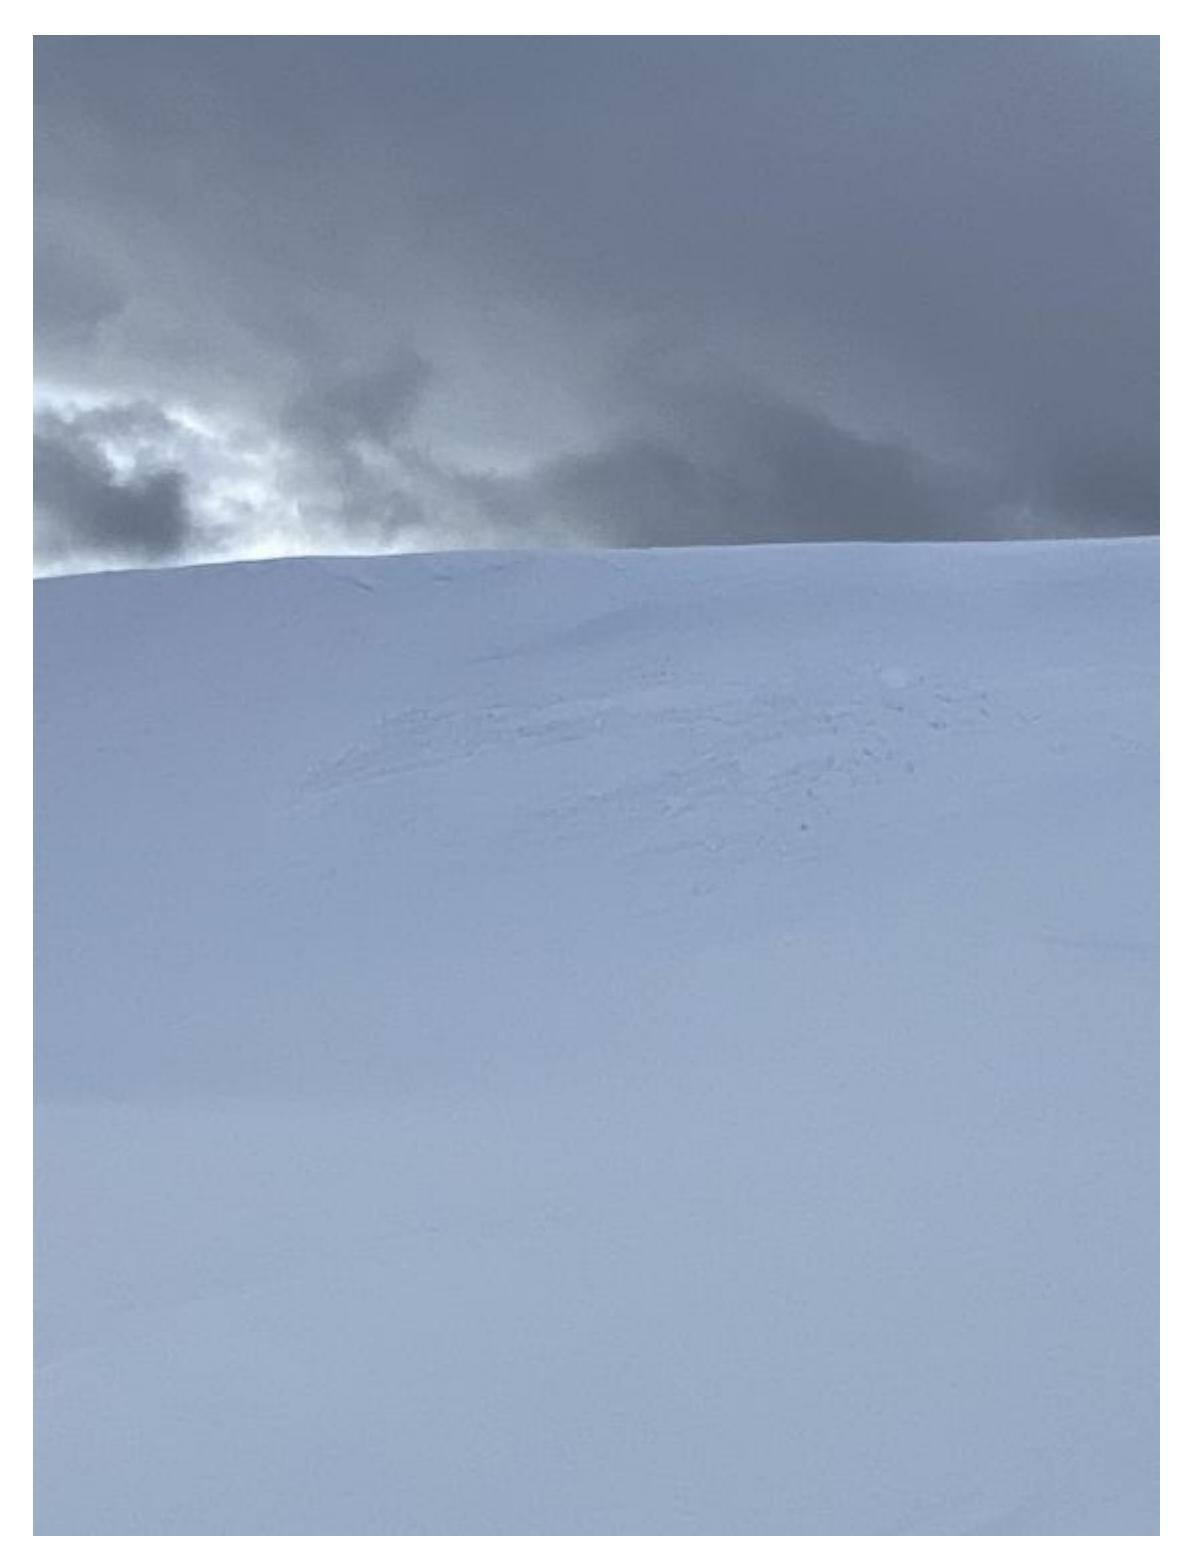
Cornice dropped in Slats and propagated slab at a weak layer of facets around 70cm height from ground. Dug a snow pit of 140cm and got etc results on the same layer ECTP26 stubborn but holds a large consequence. Photo: Z. Bailey
